Program for - Equine Performance Testing Center

GH2 | GRALLA EQUINE
ARCHITECTS™

May 28, 2014

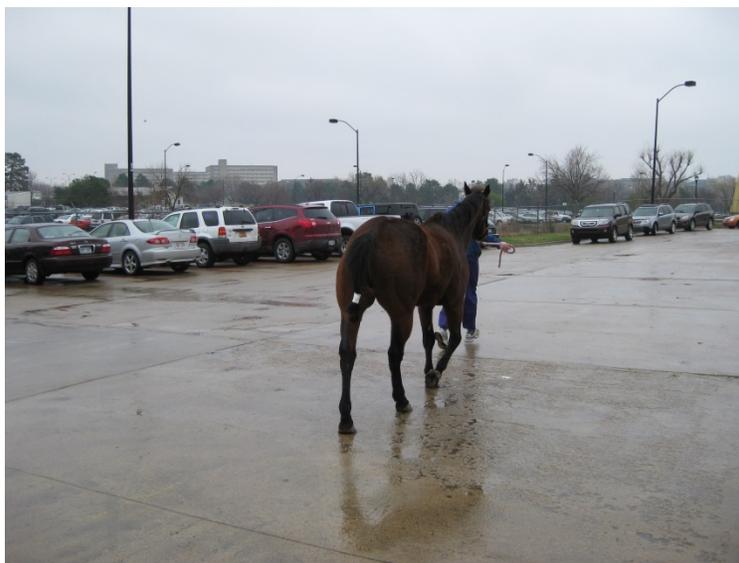
Figure 1: An equine patient at the VHC during a lameness examination in cold, wet weather in the parking lot. Note that all parking spaces are filled; the movement of any vehicle has an impact on the examination and movement of this equine patient.

We generally perform lameness examinations indoors on a paved corridor or outdoors in our parking lot. Working in the parking lot is suboptimal from a safety perspective. During high traffic periods it is possible that automobile accidents with client animals could occur. Even though we have an asphalt area for longeing purposes, we do not have an enclosed facility for observation of horses while being ridden. If weather conditions are unfavorable (rain, sleet, snow, strong winds) we are required to examine patients on the paved corridor exclusively, which precludes our ability to observe horses other than in a straight line. Longeing or riding is not possible on the paved corridor which measures 20 feet in width. It should be noted that the absolute minimum dimensions for safely working a horse in a circle for lameness examination are approximately 30 feet. We have, therefore, proposed that an indoor enclosure be built to allow for a safe, consistent environment to observe horses during gait analysis.

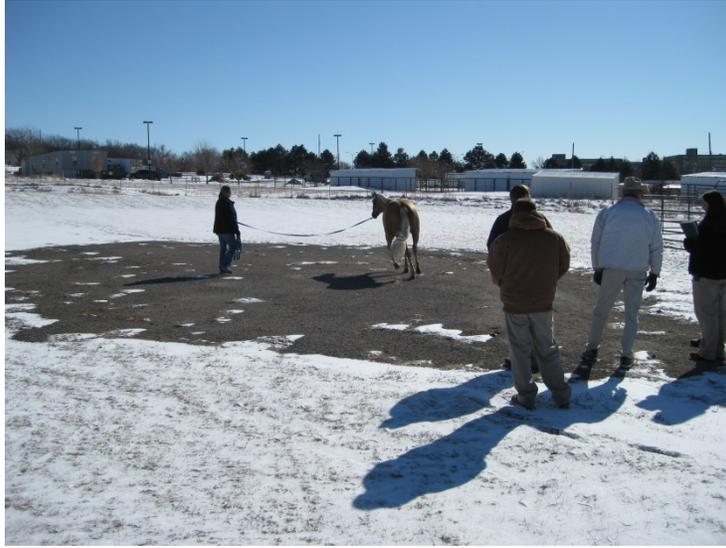
Figure 2: An equine patient at KSU during a winter time lameness exam, the daily temperature is below freezing and the examination is taking place in snowy conditions. There is no option for observation under saddle. The only soft footing area for examination is in snow which is slippery and dangerous for patient and rider.

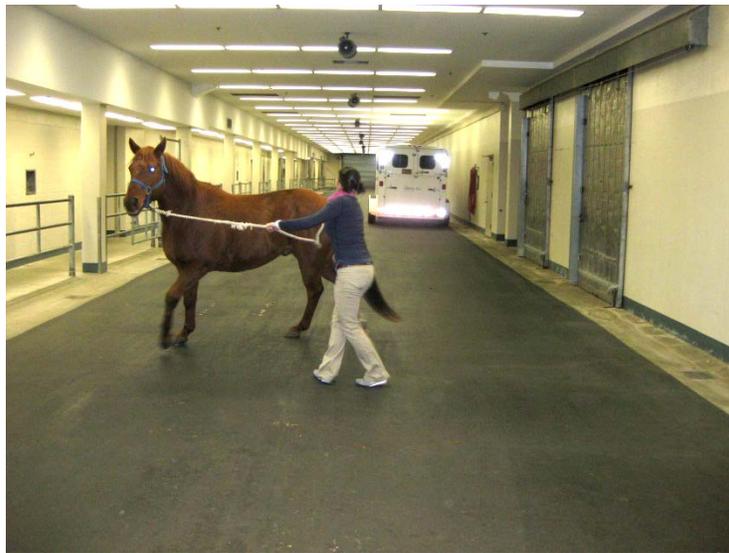
Figure 3: An equine patient that is attempting to be lunged on the paved corridor. The patient could not be examined outdoors, yet there is insufficient room to safely lunge the horse in a circle indoors. Standard length of rope for a horse for longeing is 35 feet; the entire width of this corridor is only 20 feet. The rope that is being used on this horse is 8 feet. The examination could not be performed.

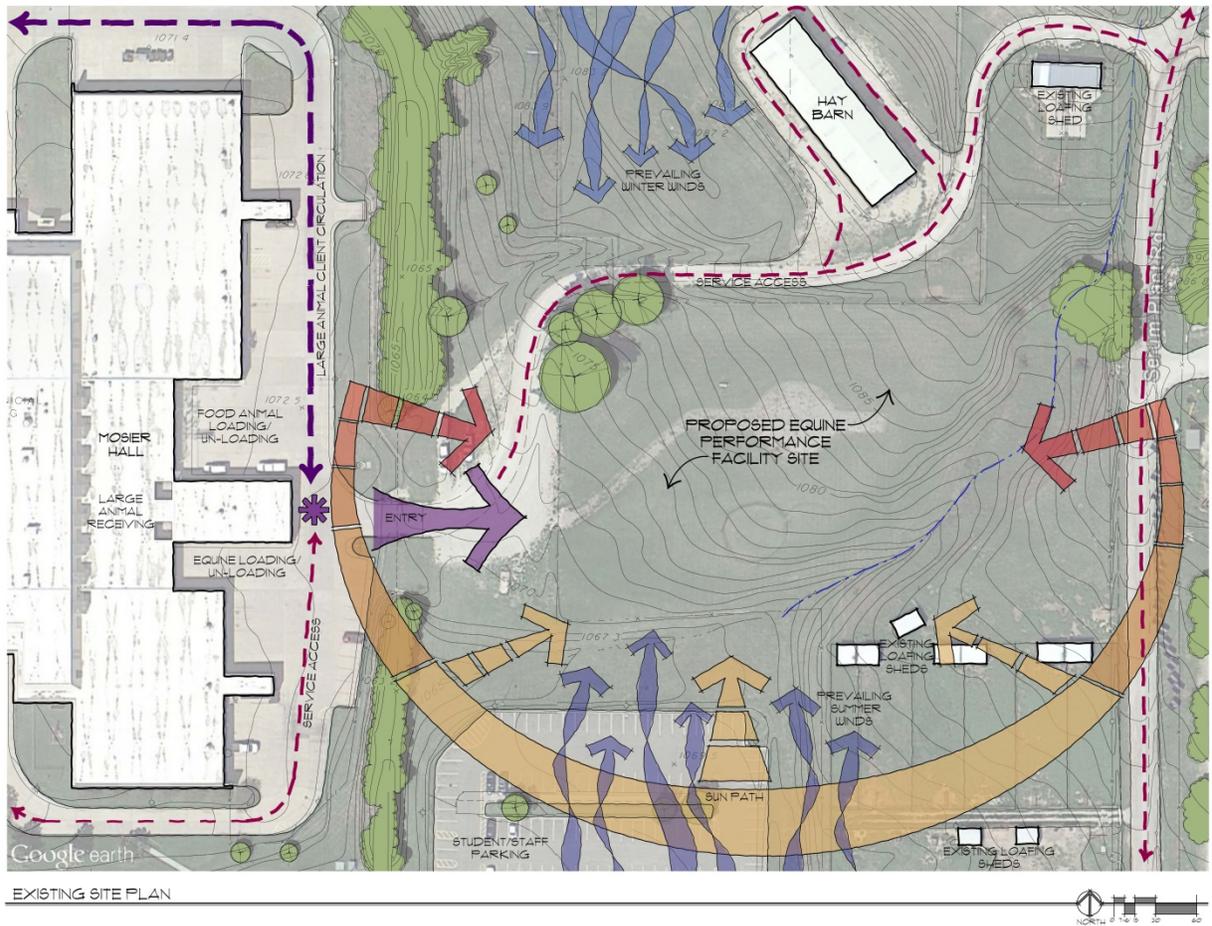
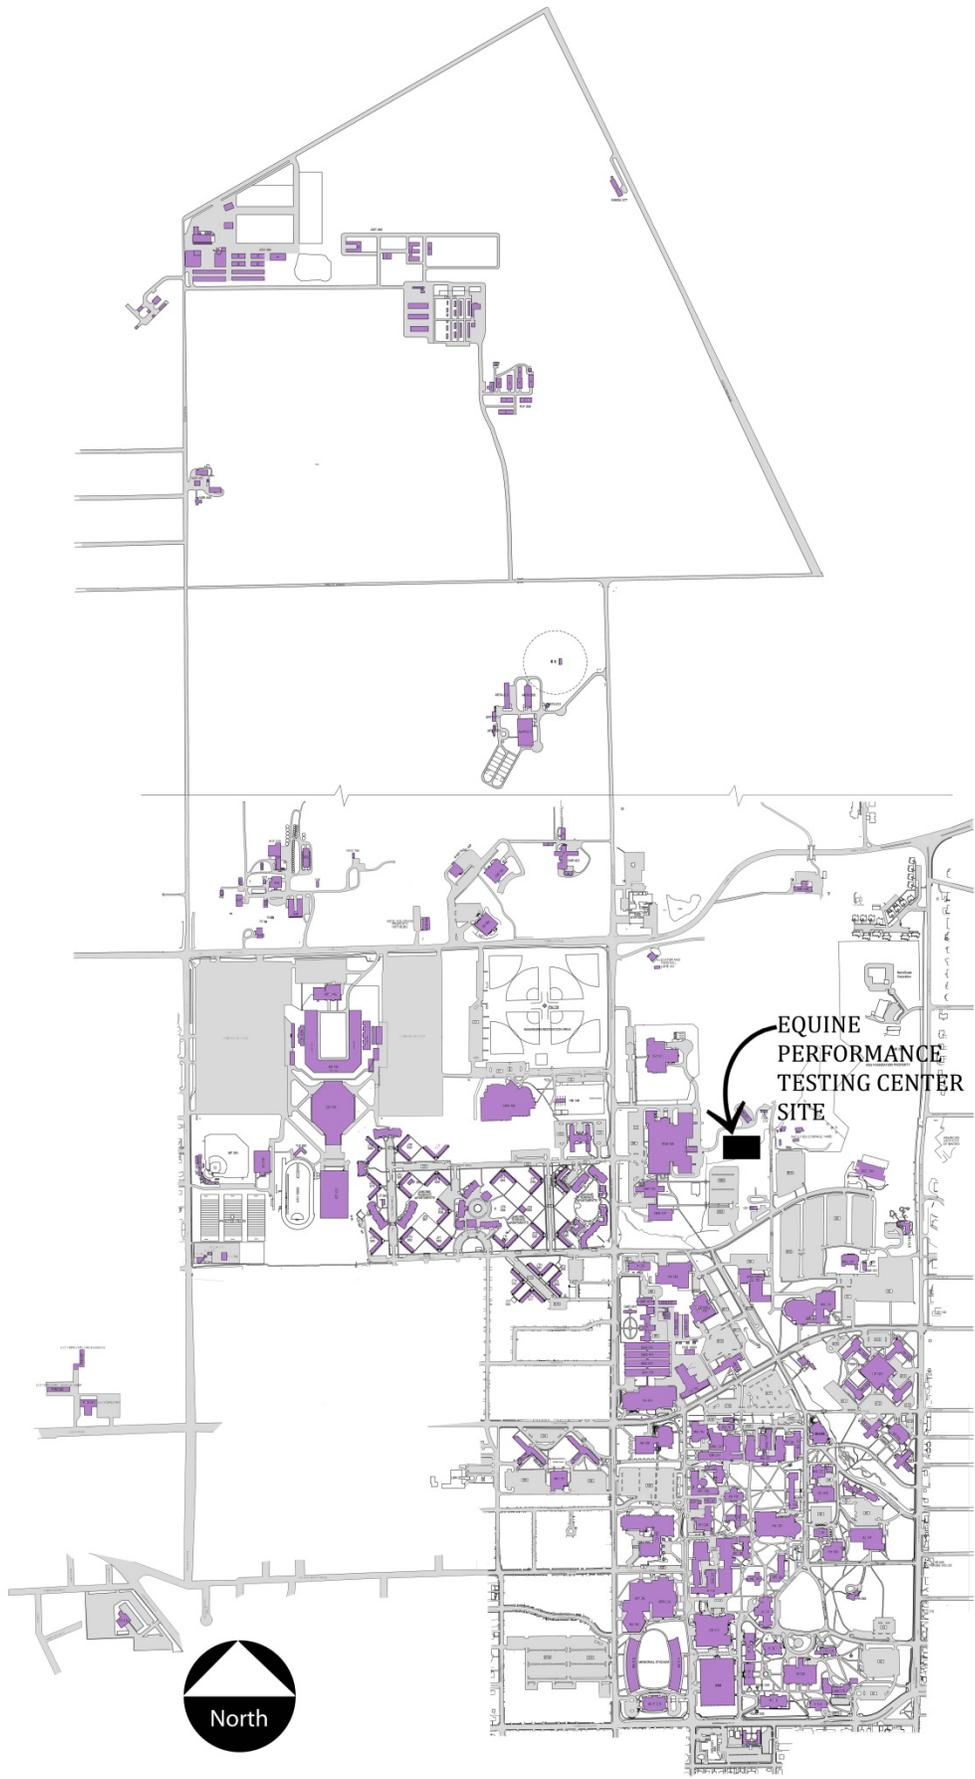
EQUINE
PERFORMANCE
TESTING CENTER
SITE

The proposed Equine Performance Testing Center will be located on Kansas State University's campus, within the Veterinary Health Center complex. The site is located to the East of Mosier Hall. Vehicular access to the site is provided from Denison Avenue through the existing Veterinary Medicine Large Animal Circulation / Service Road located at the North and East of Mosier Hall. Additional service access is provided using Serum Plant Road.

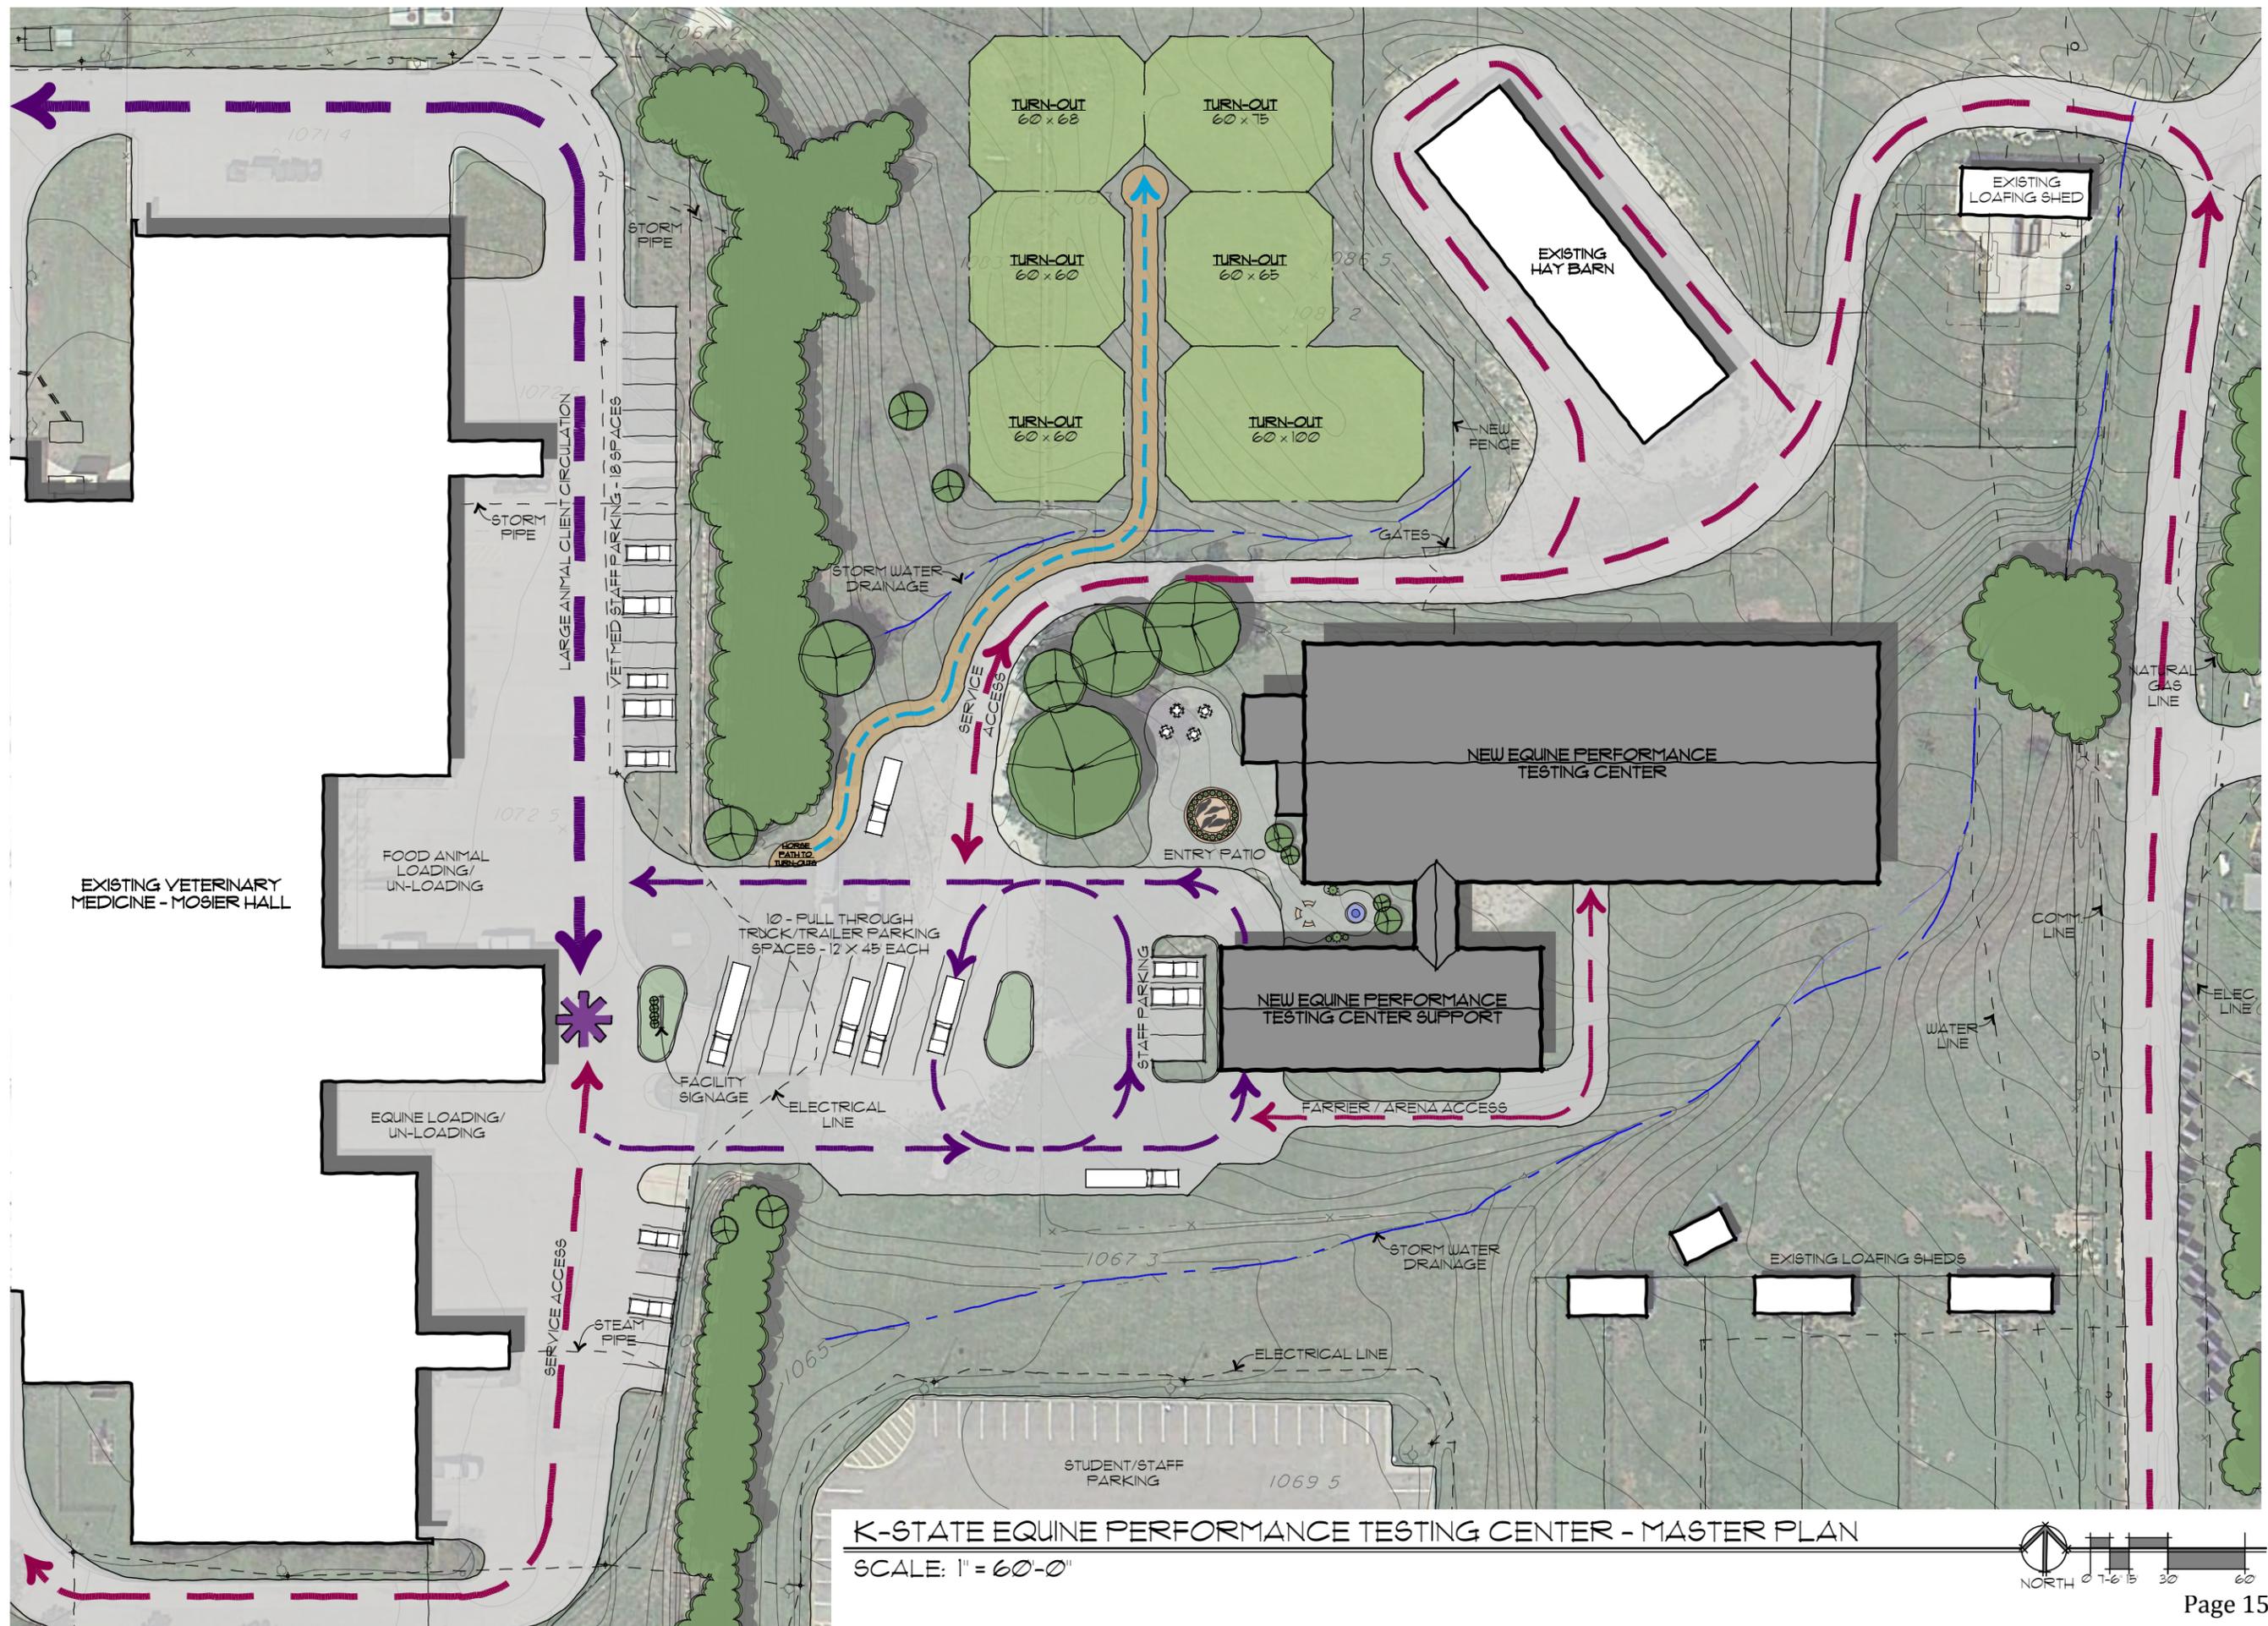
K-STATE EQUINE PERFORMANCE TESTING CENTER - MASTER PLAN
 SCALE: 1" = 60'-0"

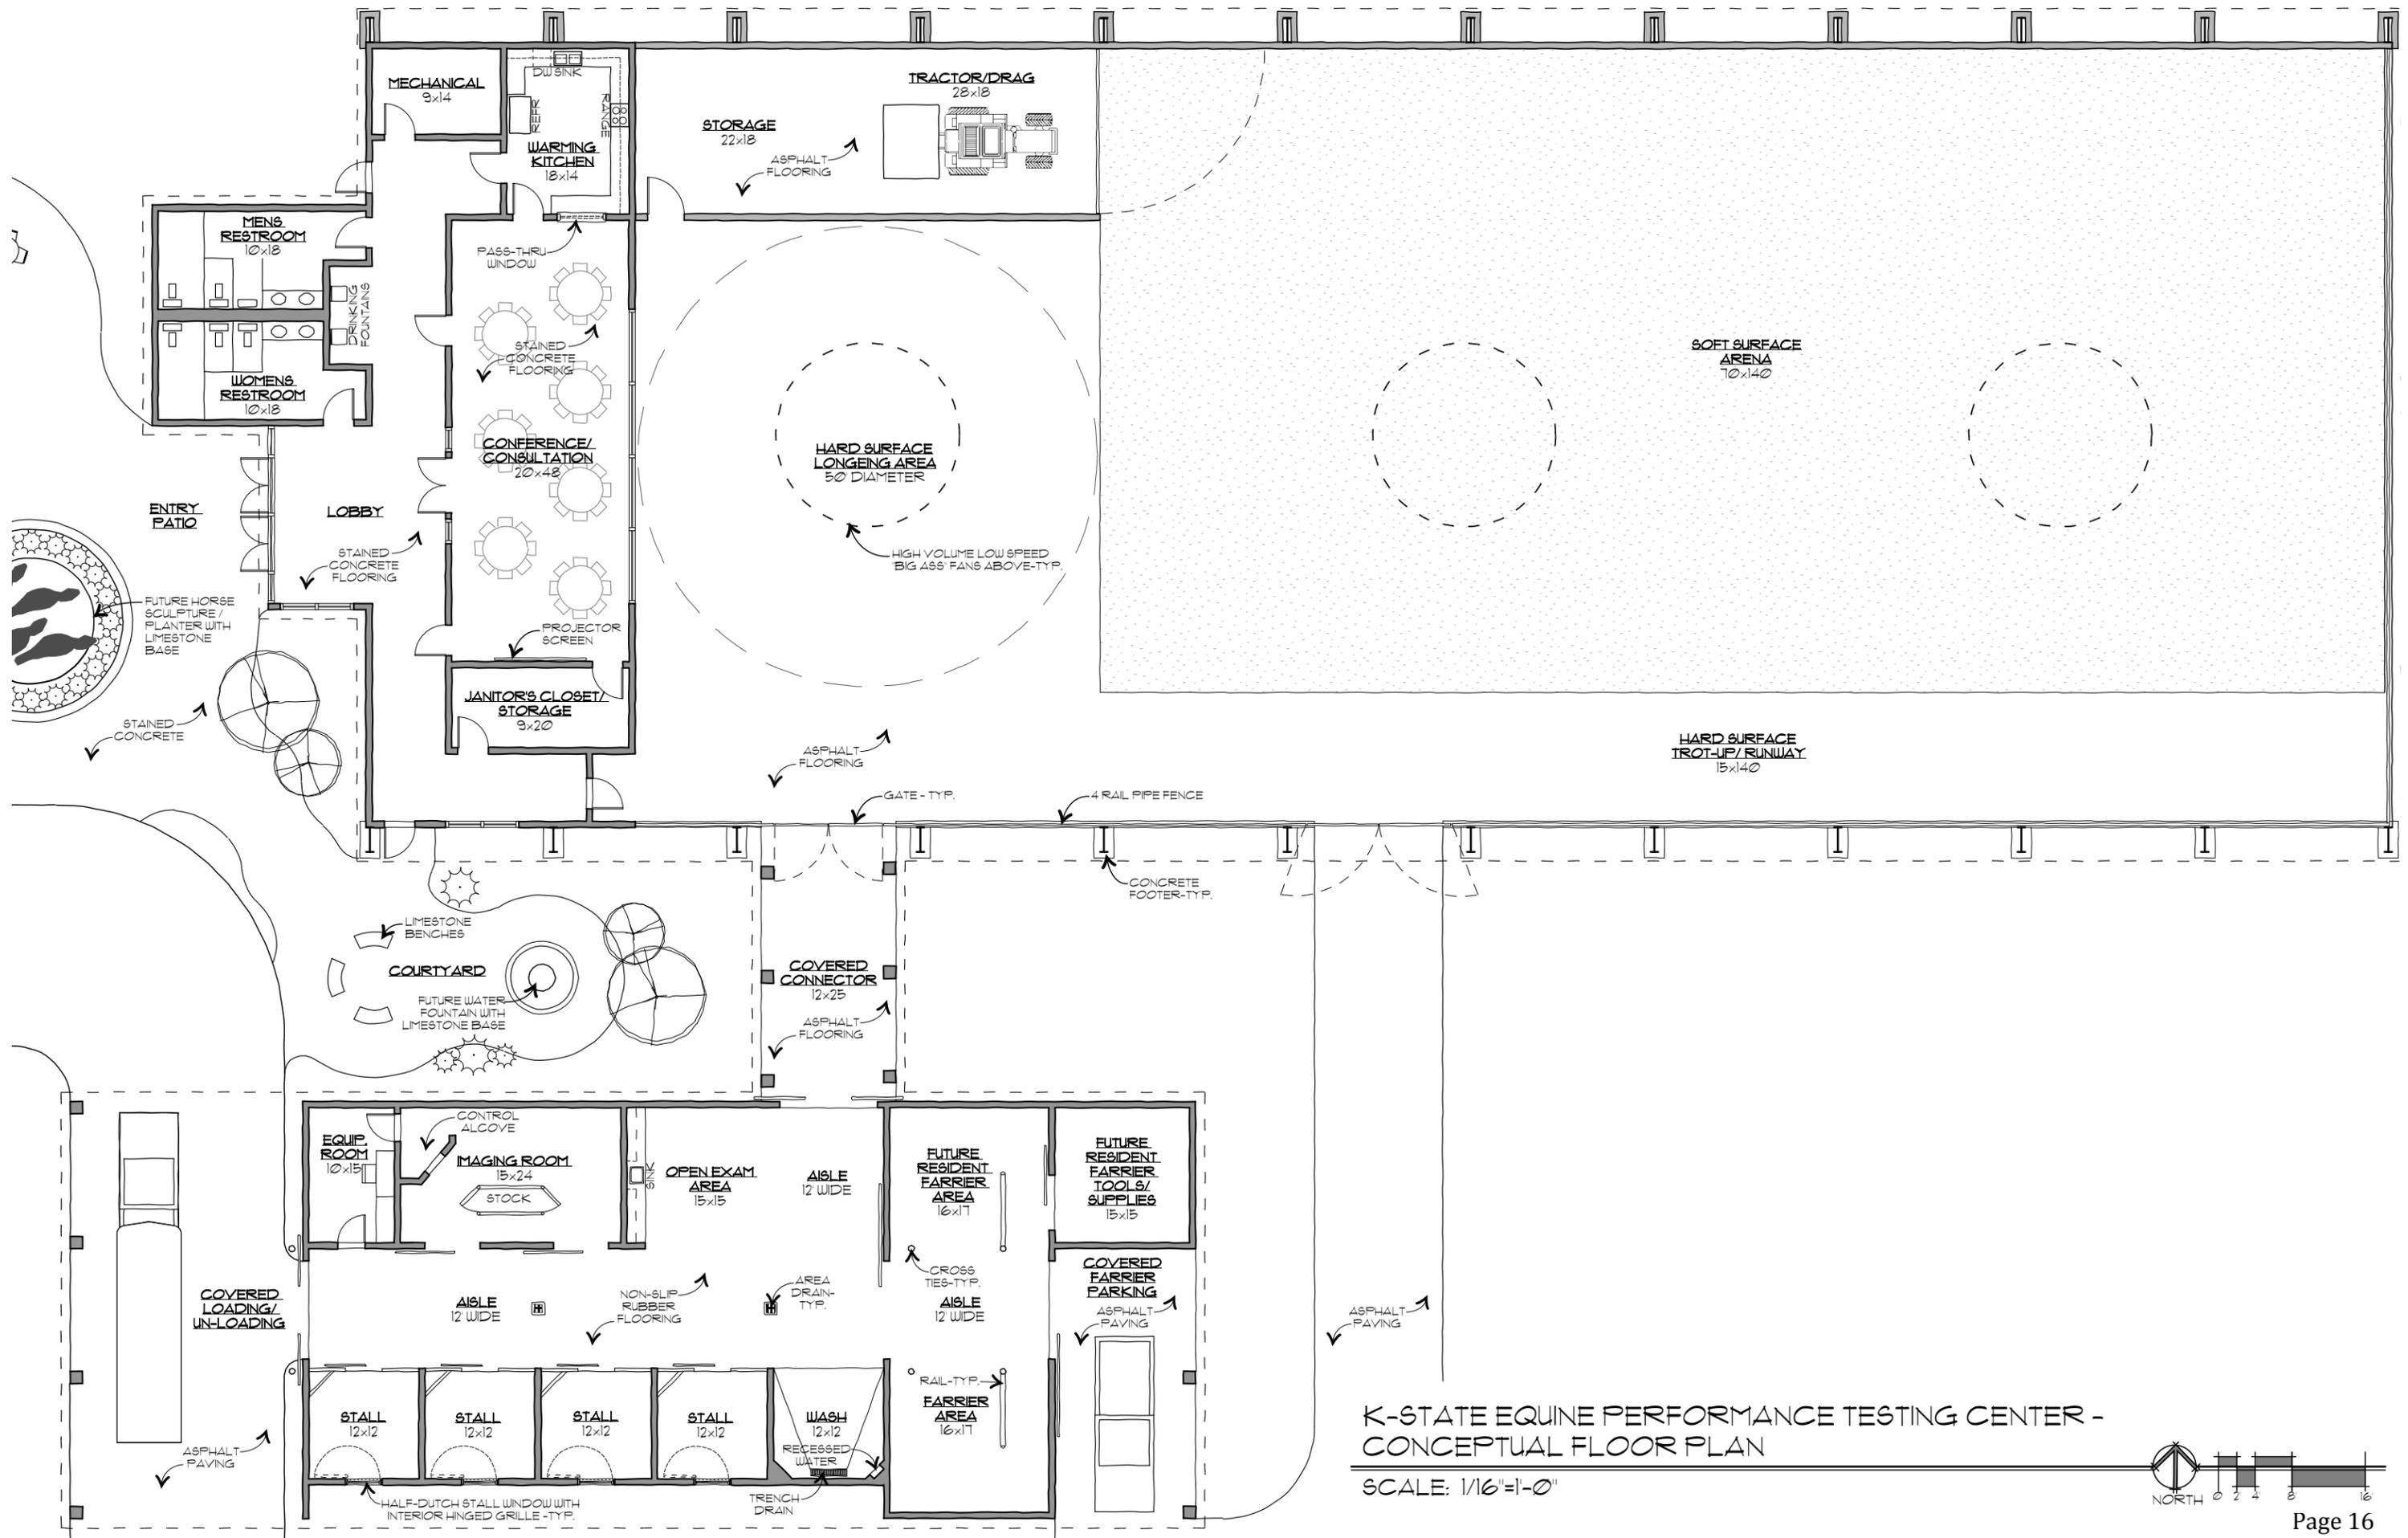
K-STATE EQUINE PERFORMANCE TESTING CENTER -
 CONCEPTUAL FLOOR PLAN
 SCALE: 1/16"=1'-0"

The proposed EPTC will contain a soft footing riding arena with approximate dimensions of 70' x 140'. In addition to a riding arena the EPTC will contain an area of asphalt footing to include a 50' diameter circular area for longeing purposes as well as a 15' x 140' runway for comprehensive lameness examination. The purpose for the separate areas is to provide an area with soft footing for general evaluation and under saddle assessment, whereas the firm footing surface will provide an area for examination that will accentuate subtle lameness that may not be evident in the soft footing areas. Collectively, the soft footing arena and asphalt areas will allow for a comprehensive examination that will involve both in hand and under saddle examinations. The indoor facility will enable the equine clinicians to examine patients and teach veterinary students 12 months of the year in a safe and effective environment.

Four holding stalls will be included for outpatient purposes. An area for farrier services is a core need to horses that come to the EPTC for examination and diagnostic testing. An essential component of complete equine lameness examination involves radiographic capabilities. Therefore a radiographic imaging area has also been included in the design of the facility. In an effort to complete the mission of this land grant institution, the facility will include a conference room which will provide an area for client services, student education and outreach activities involving the local and regional Kansas community.

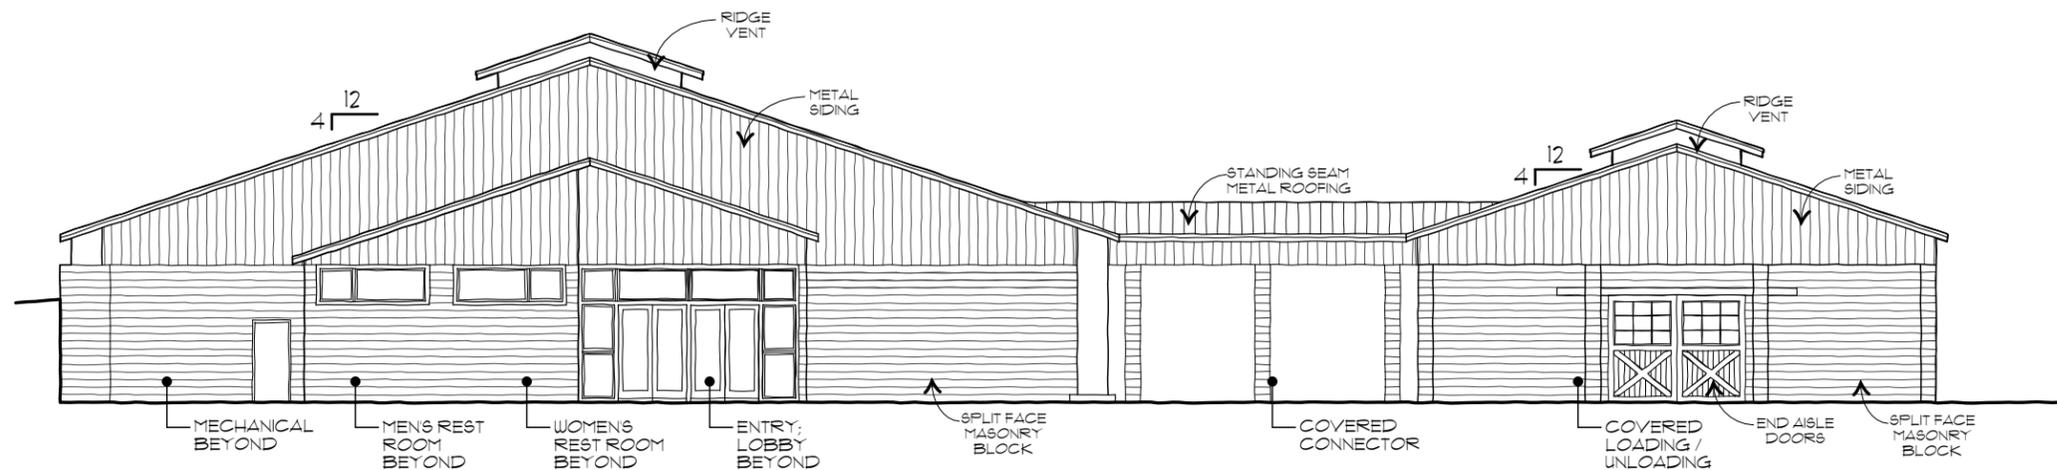
B K-STATE EQUINE PERFORMANCE TESTING CENTER - CONCEPTUAL WEST ELEVATION
 SCALE: 1/16"=1'-0"

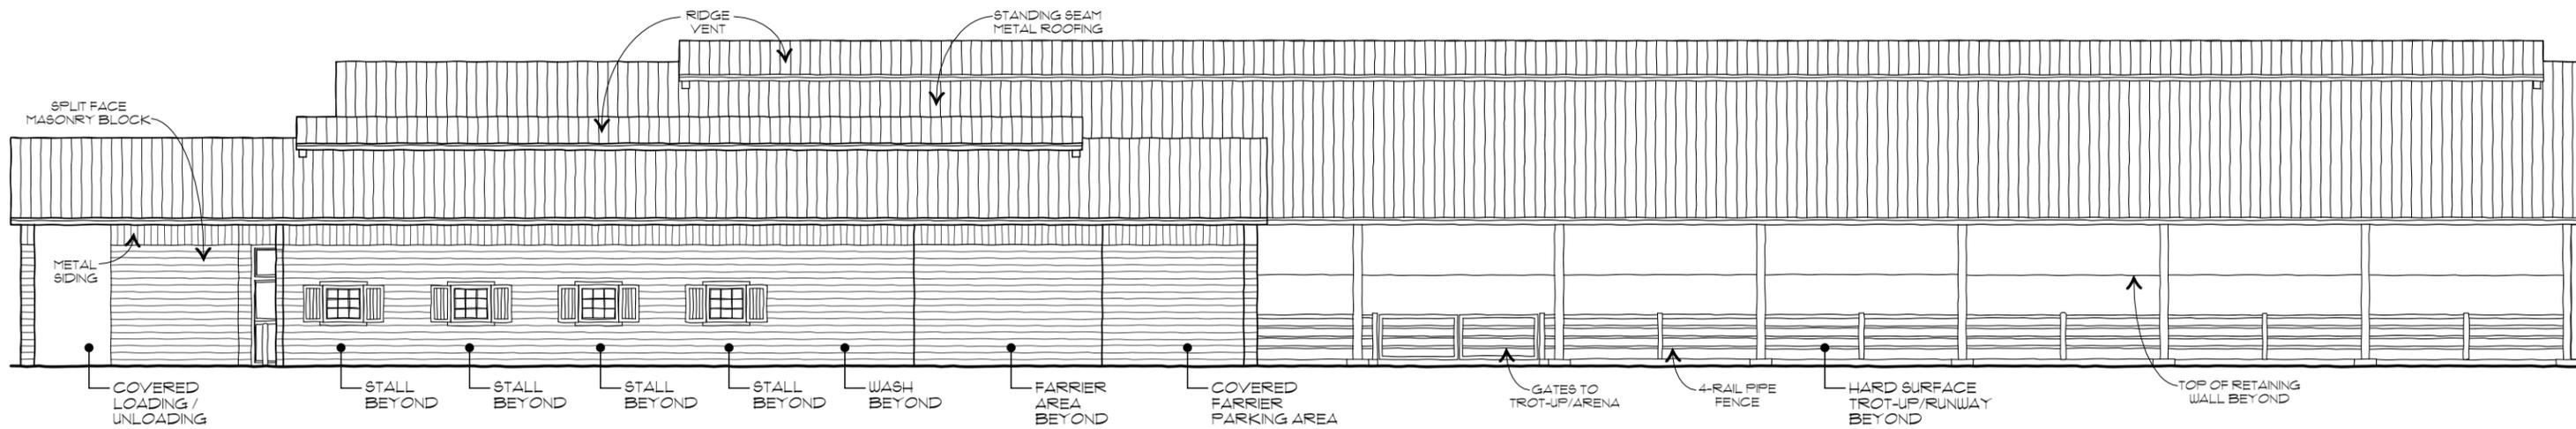
A K-STATE EQUINE PERFORMANCE TESTING CENTER - CONCEPTUAL SOUTH ELEVATION
 SCALE: 1/16"=1'-0"
